February 6, 2023 Contractor HASP Submittal to EPA

From: Brussel, John
Sent: Monday, February 6, 2023 9:23 PM
To: Bilash, Kevin
Cc: Stearns, Brian M.; Sheehan, Daniel P.; Healy, Lawrence
Subject: Contractor's Construction HASP - Former Philadelphia Coke Site, 4501 Richmond Street, Philadelphia, PA

**PROJECT HEALTH & SAFETY PLAN (HASP)
BRIDGE POINT BRIDESBURG LLC
4501 RICHMOND STREET
PHILADELPHIA, PA**

Envirosearch Project # 43322

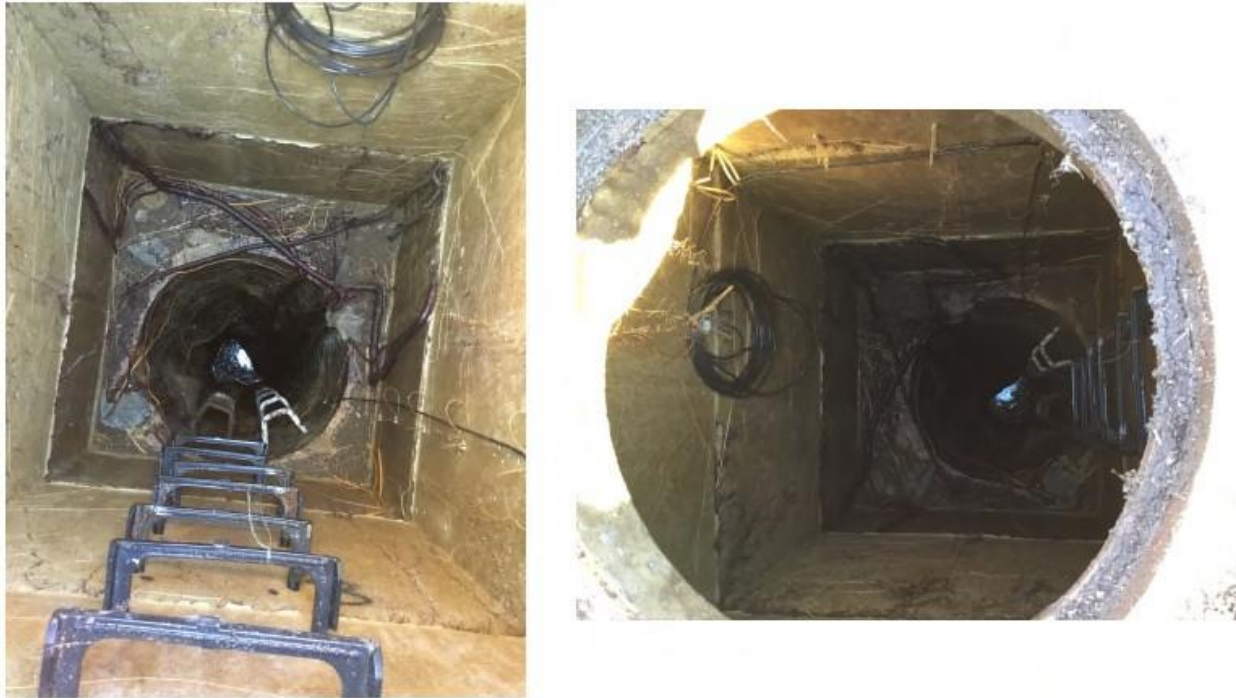
Figure 3-1: Downhole Photos of MH-4

Water was observed in the manhole at a depth of 26.5 bgs (equivalent to negative 13.29 feet NAVD 88). Groundwater elevations beneath the Site within the vicinity of the Upper Delaware Collecting Sewer range from approximately positive 6 to 8 feet NAVD 88, which is approximately 19 feet above the water level in the sewer. Based on this large head difference and as indicated in the existing shallow zone potentiometric surface maps, the Upper Delaware Collecting Sewer appears to have little or no influence on groundwater flow patterns at the Site. Accordingly, any groundwater collected by the sewer would be negligible.

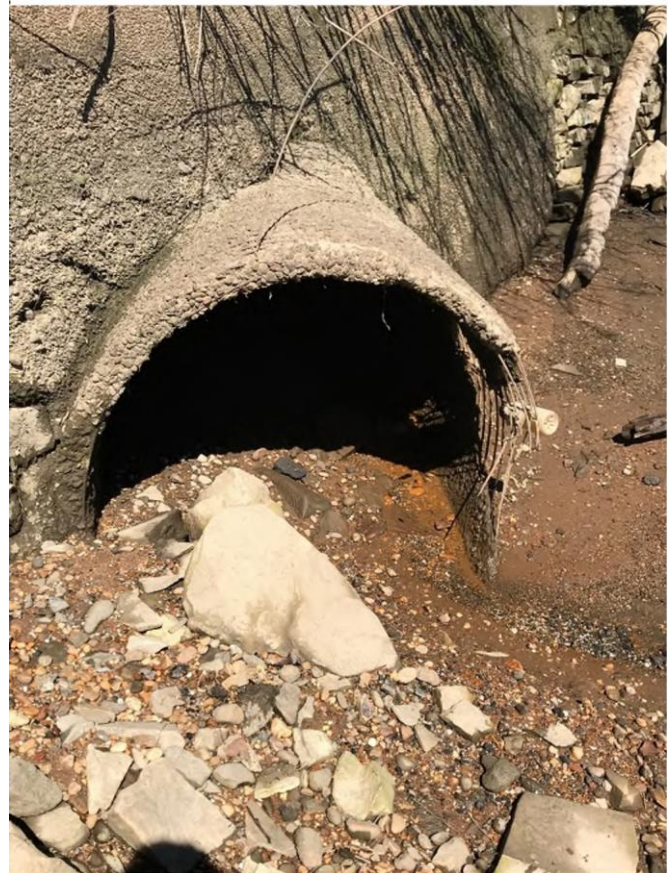
Figure 3-2: Outfall 001

or other indications of Site-related impacts. The sediment was soft and silty. A metal rod was commonly advanced 3 to 4 feet in the sediment and at some locations up to 5 feet into the sediment. No oil-like sheens, elevated PID readings, or noticeable odors were observed. Volatile organics were not detected (i.e., PID readings were 0.0 parts per million [ppm]) at these film locations. Based on the probing observations, sediment was not further evaluated.

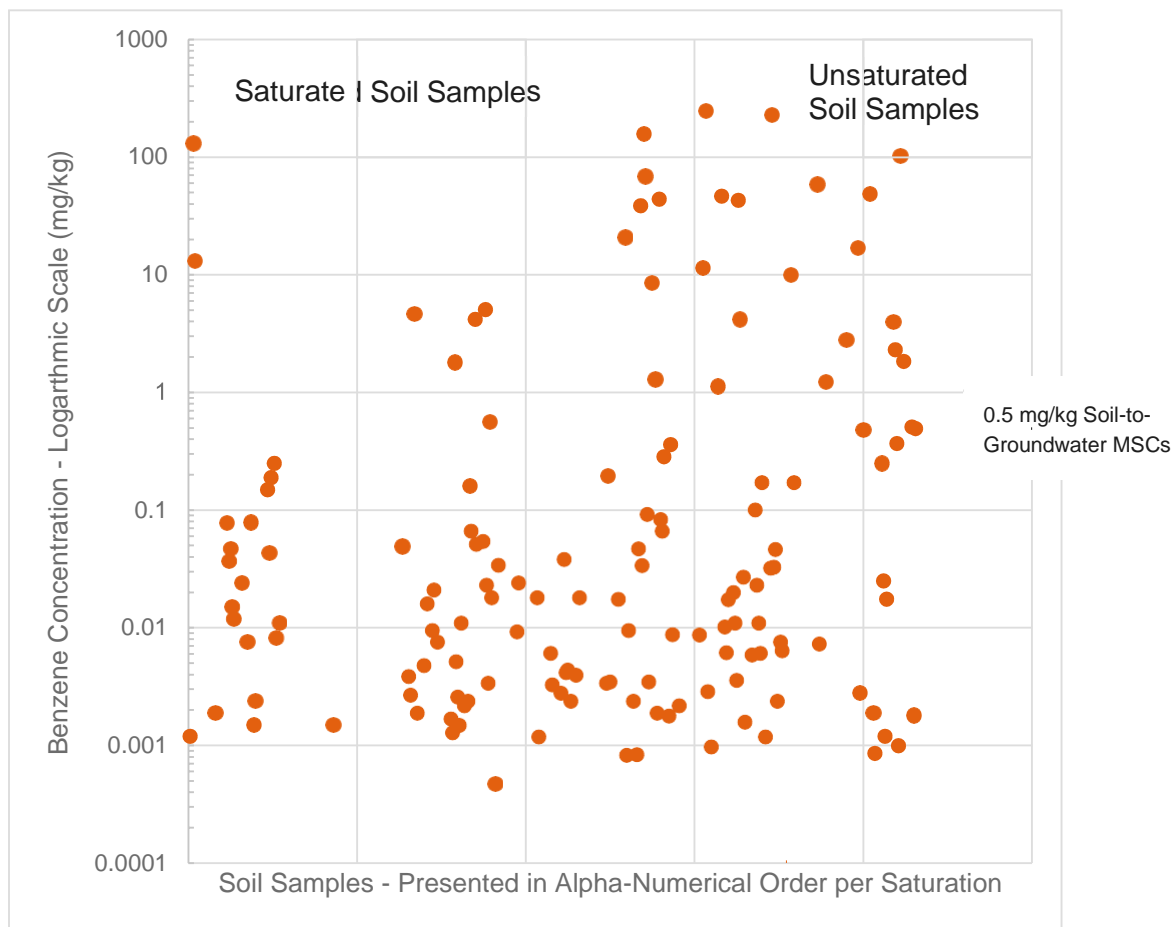
Figure 3-3: Distribution of Benzene Concentrations in Subsurface Soil Samples

Note: Data are presented in logarithmic scale on y-axis. Each sample where benzene was detected is represented by an orange dot. As illustrated above, most data are below the S-GW MSC for benzene of 0.5 mg/kg.

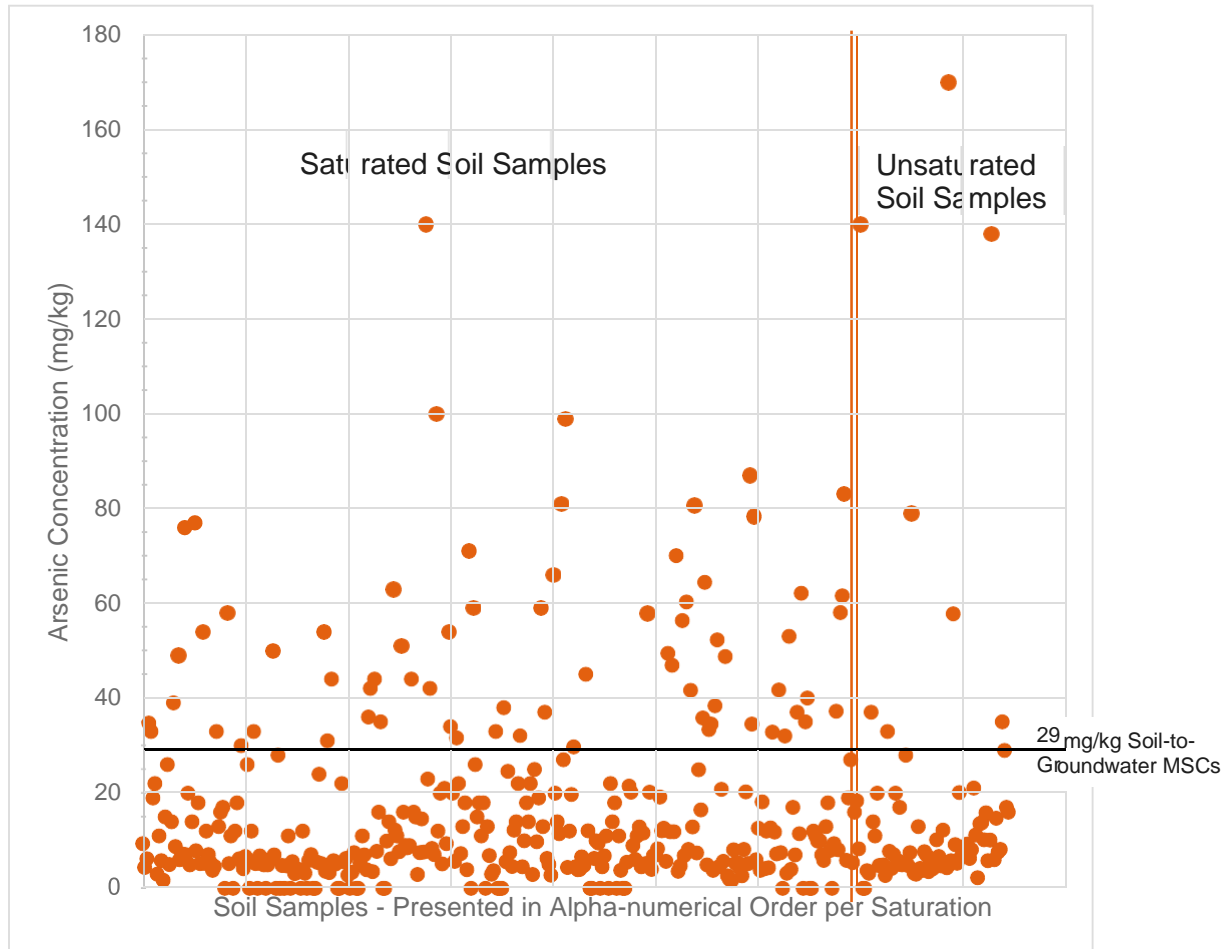
Figure 3-4: Distribution of Arsenic Concentrations in Subsurface Soil Samples

Note: Each sample is represented by an orange dot. As illustrated above, most data are below the S-GW MSC for arsenic of 29 mg/kg.

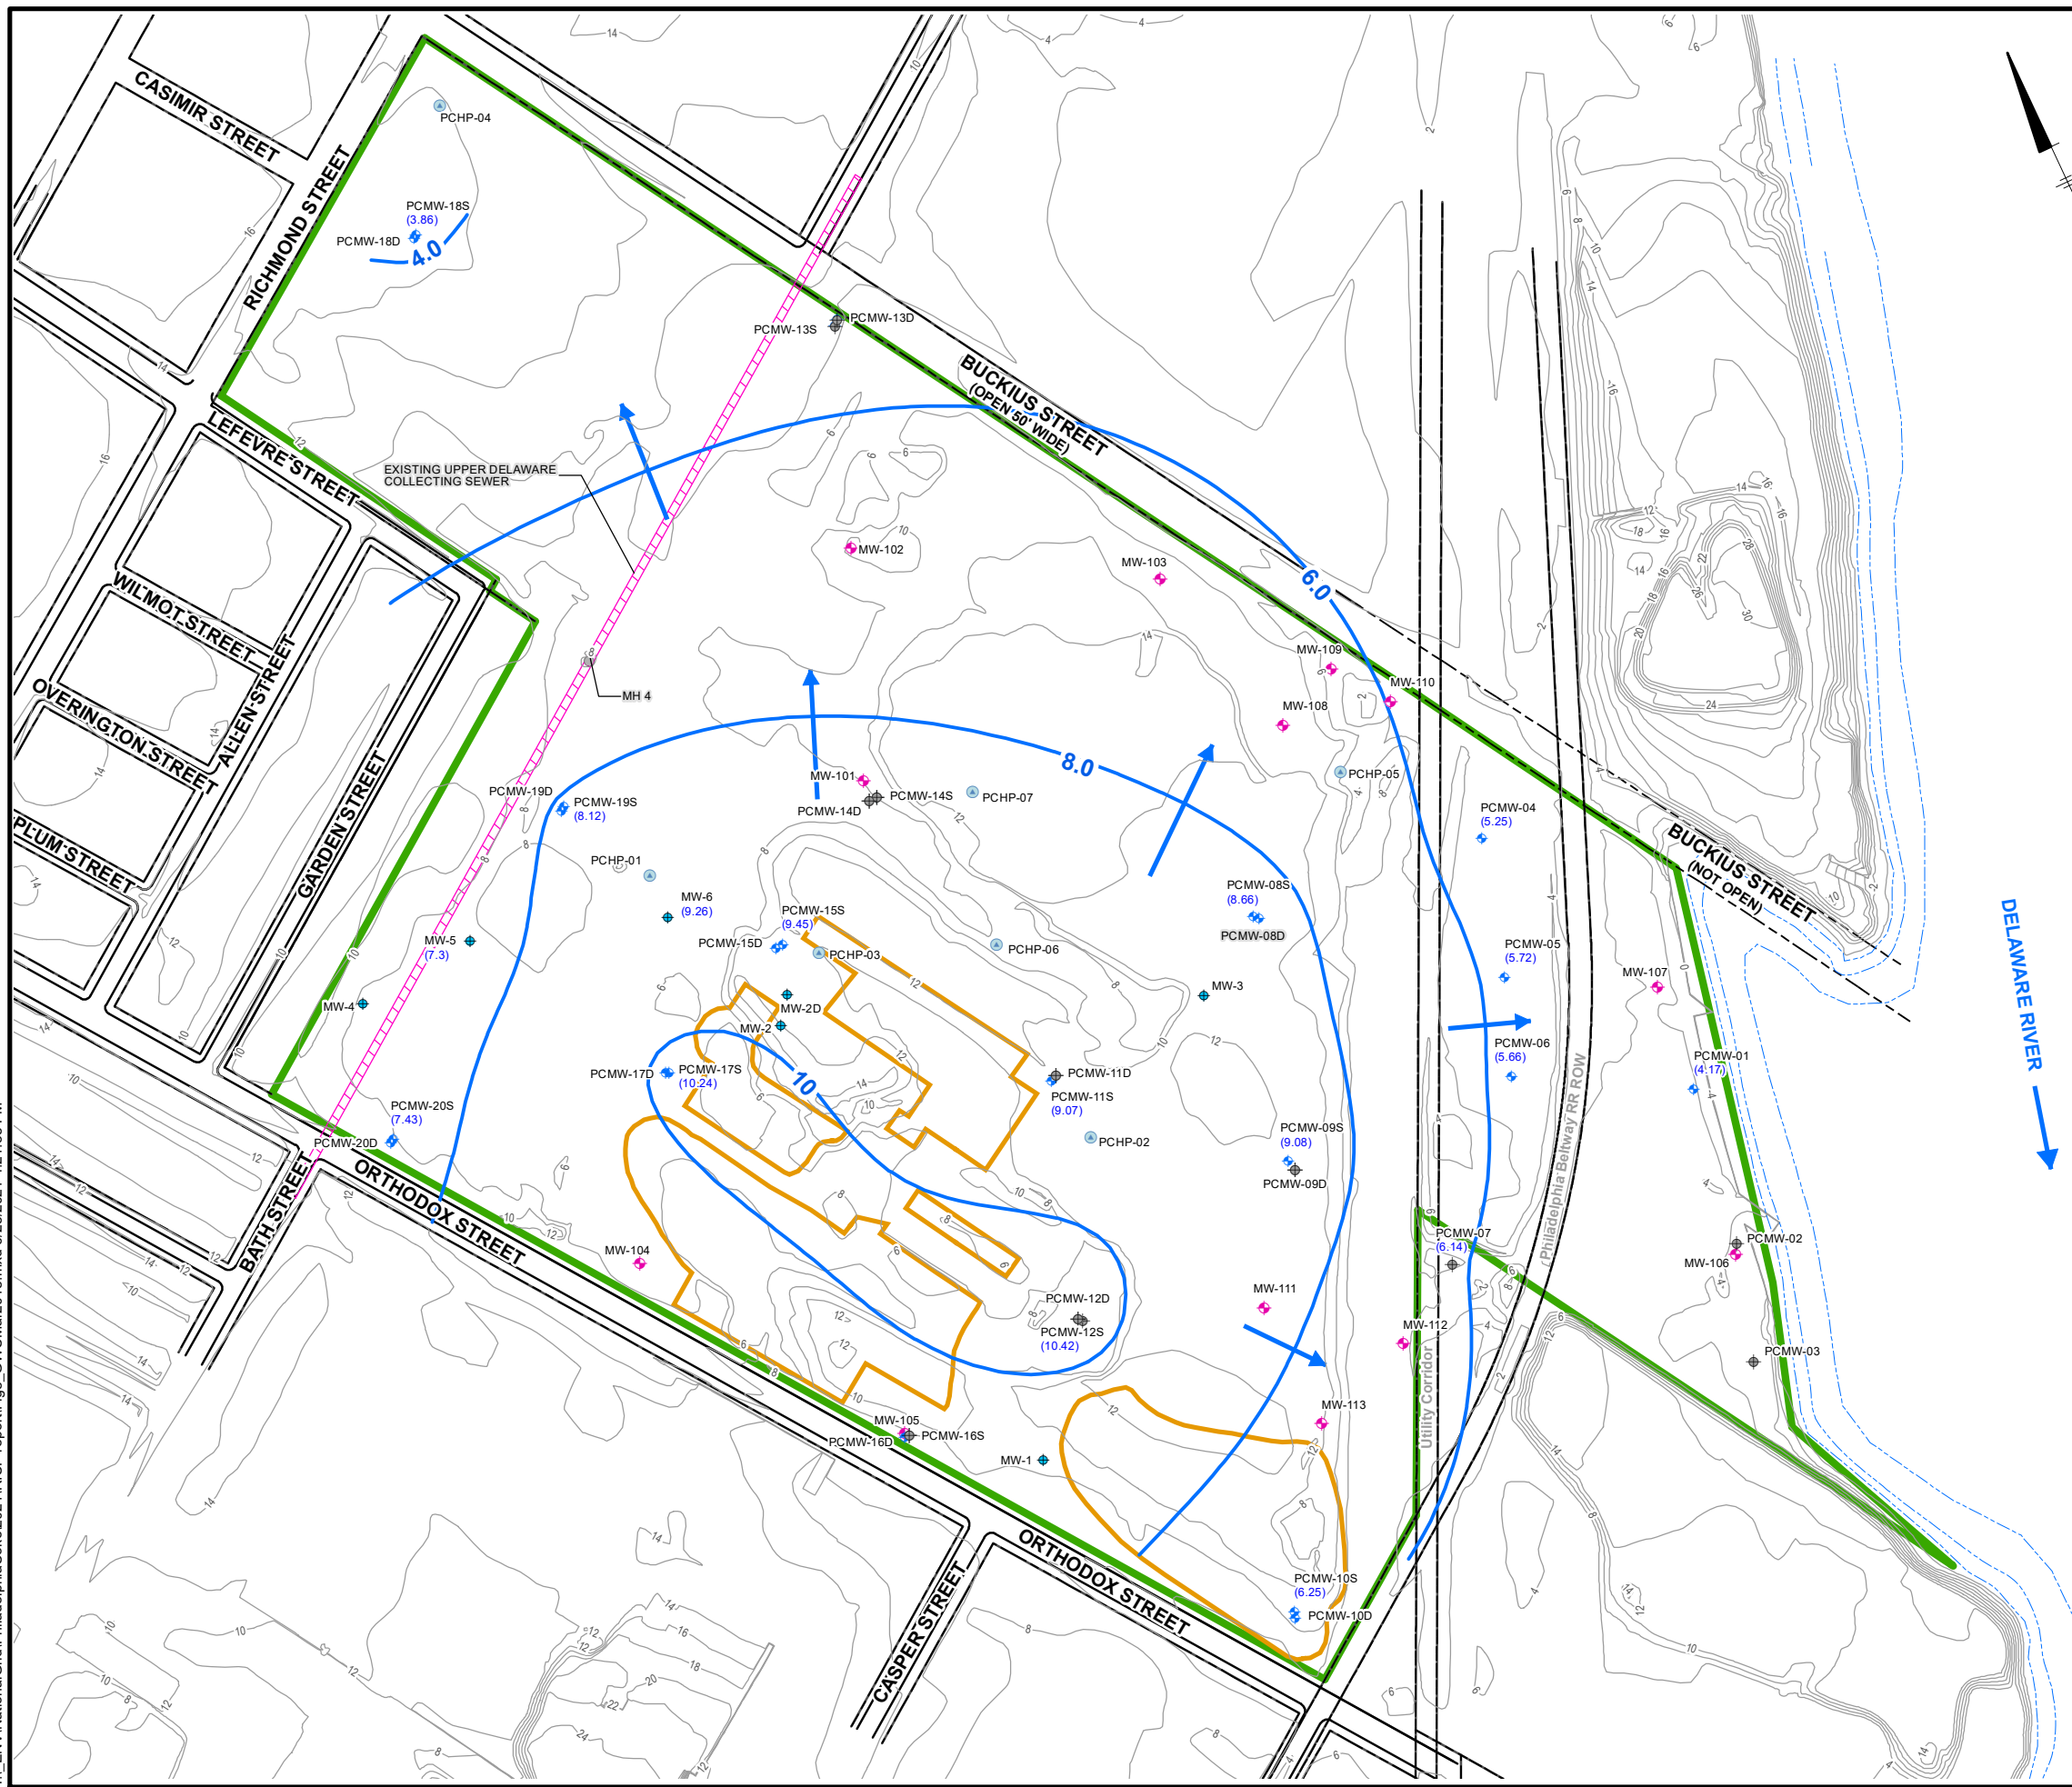
- INFERRED GROUNDWATER ELEVATION CONTOUR (FEET ABOVE MEAN SEA LEVEL, NAVD 88)
- APPROXIMATE GROUNDWATER FLOW DIRECTION
- (9.07) GROUNDWATER ELEVATION - SHALLOW ZONE (FEET ABOVE MEAN SEA LEVEL, NAVD 88)
- (MW-101) GROUNDWATER MONITORING WELL LOCATION (2018-2019)
- (PCMW-12S) PSS GROUNDWATER MONITORING WELL (2005)
- (PCMW-12D) MISSING/DESTROYED PSS GROUNDWATER MONITORING WELL
- (PCHP-03) PSS GROUNDWATER HYDROPUNCH (2005)
- (MW-5) RCRA CLOSURE GROUNDWATER MONITORING WELL (1992 AND EARLIER)
- GROUND SURFACE ELEVATION CONTOURS FROM DATA CLEARINGHOUSE PHILADELPHIA CONTOURS 2-FT. (PHILADELPHIA VERTICAL DATUM, 2004 - CITY OF PHILADELPHIA)
- FORMER RCRA EXCAVATION
- APPROXIMATE SITE BOUNDARY
- SHORELINE

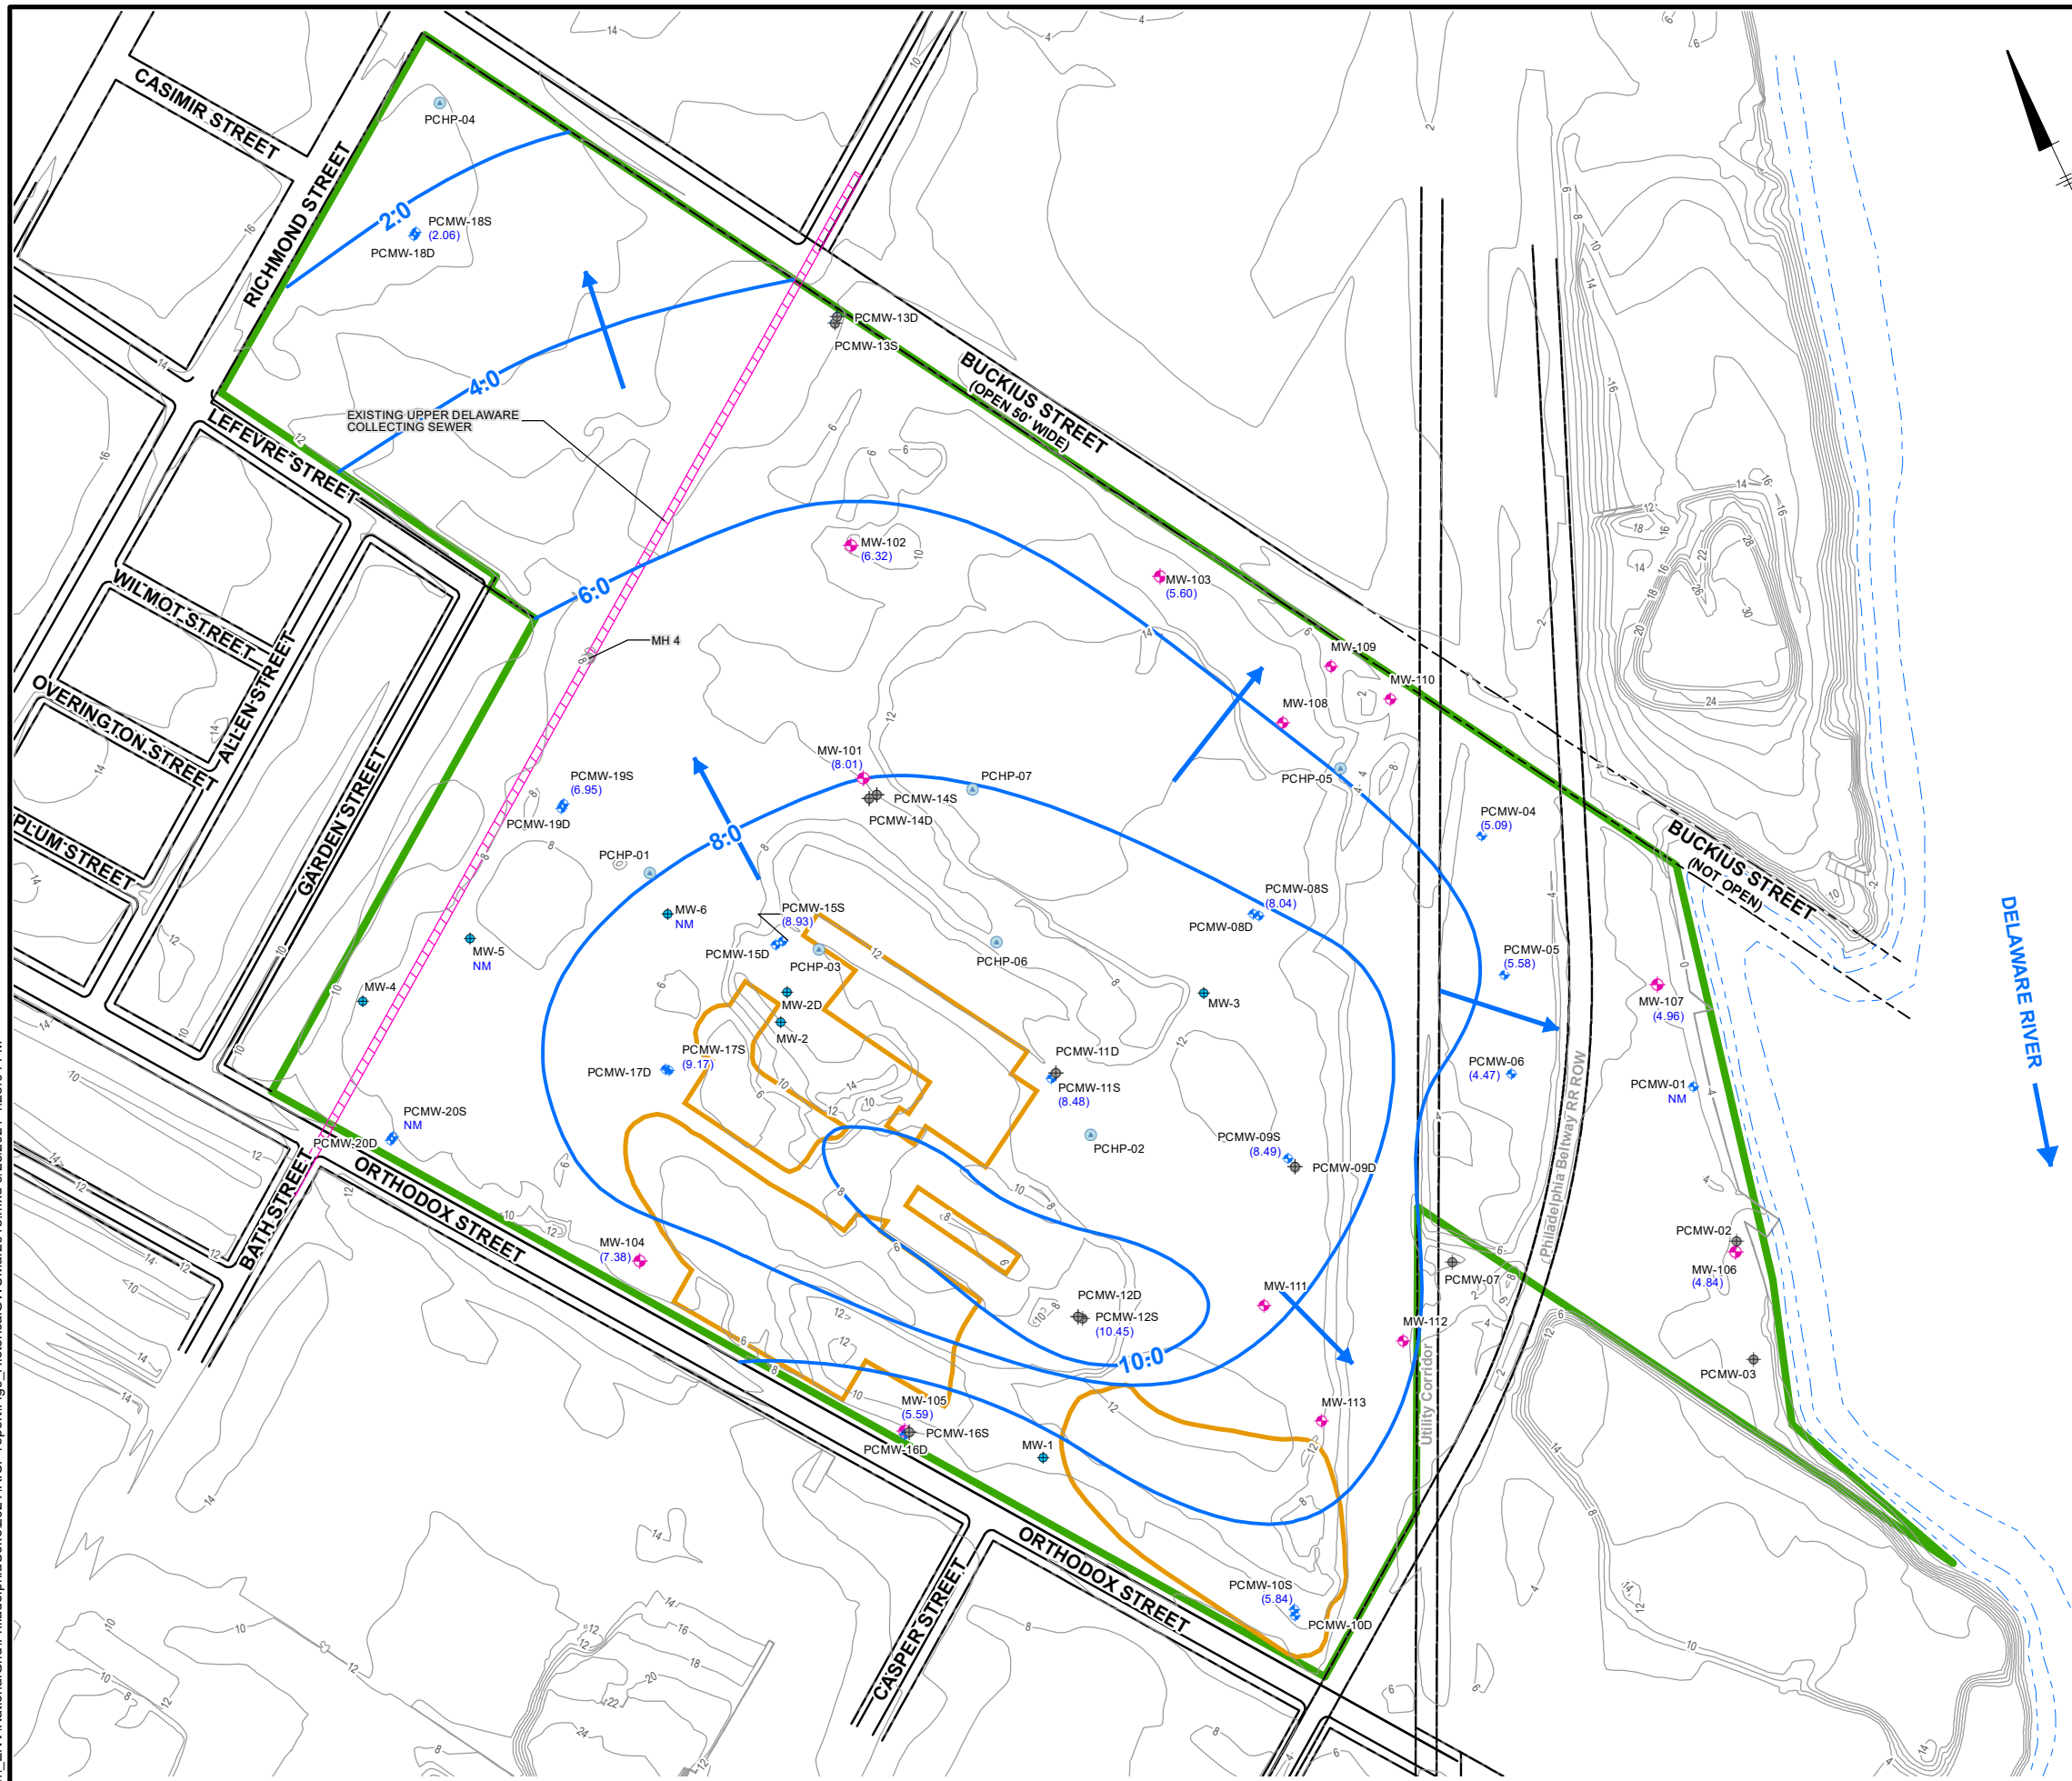
NATIONAL GRID
 FORMER PHILADELPHIA COKE PLANT
 PHILADELPHIA, PENNSYLVANIA
 RI REPORT
**GROUNDWATER POTENTIOMETRIC
 SURFACE MAP - SHALLOW ZONE
 MAY 29, 2018**

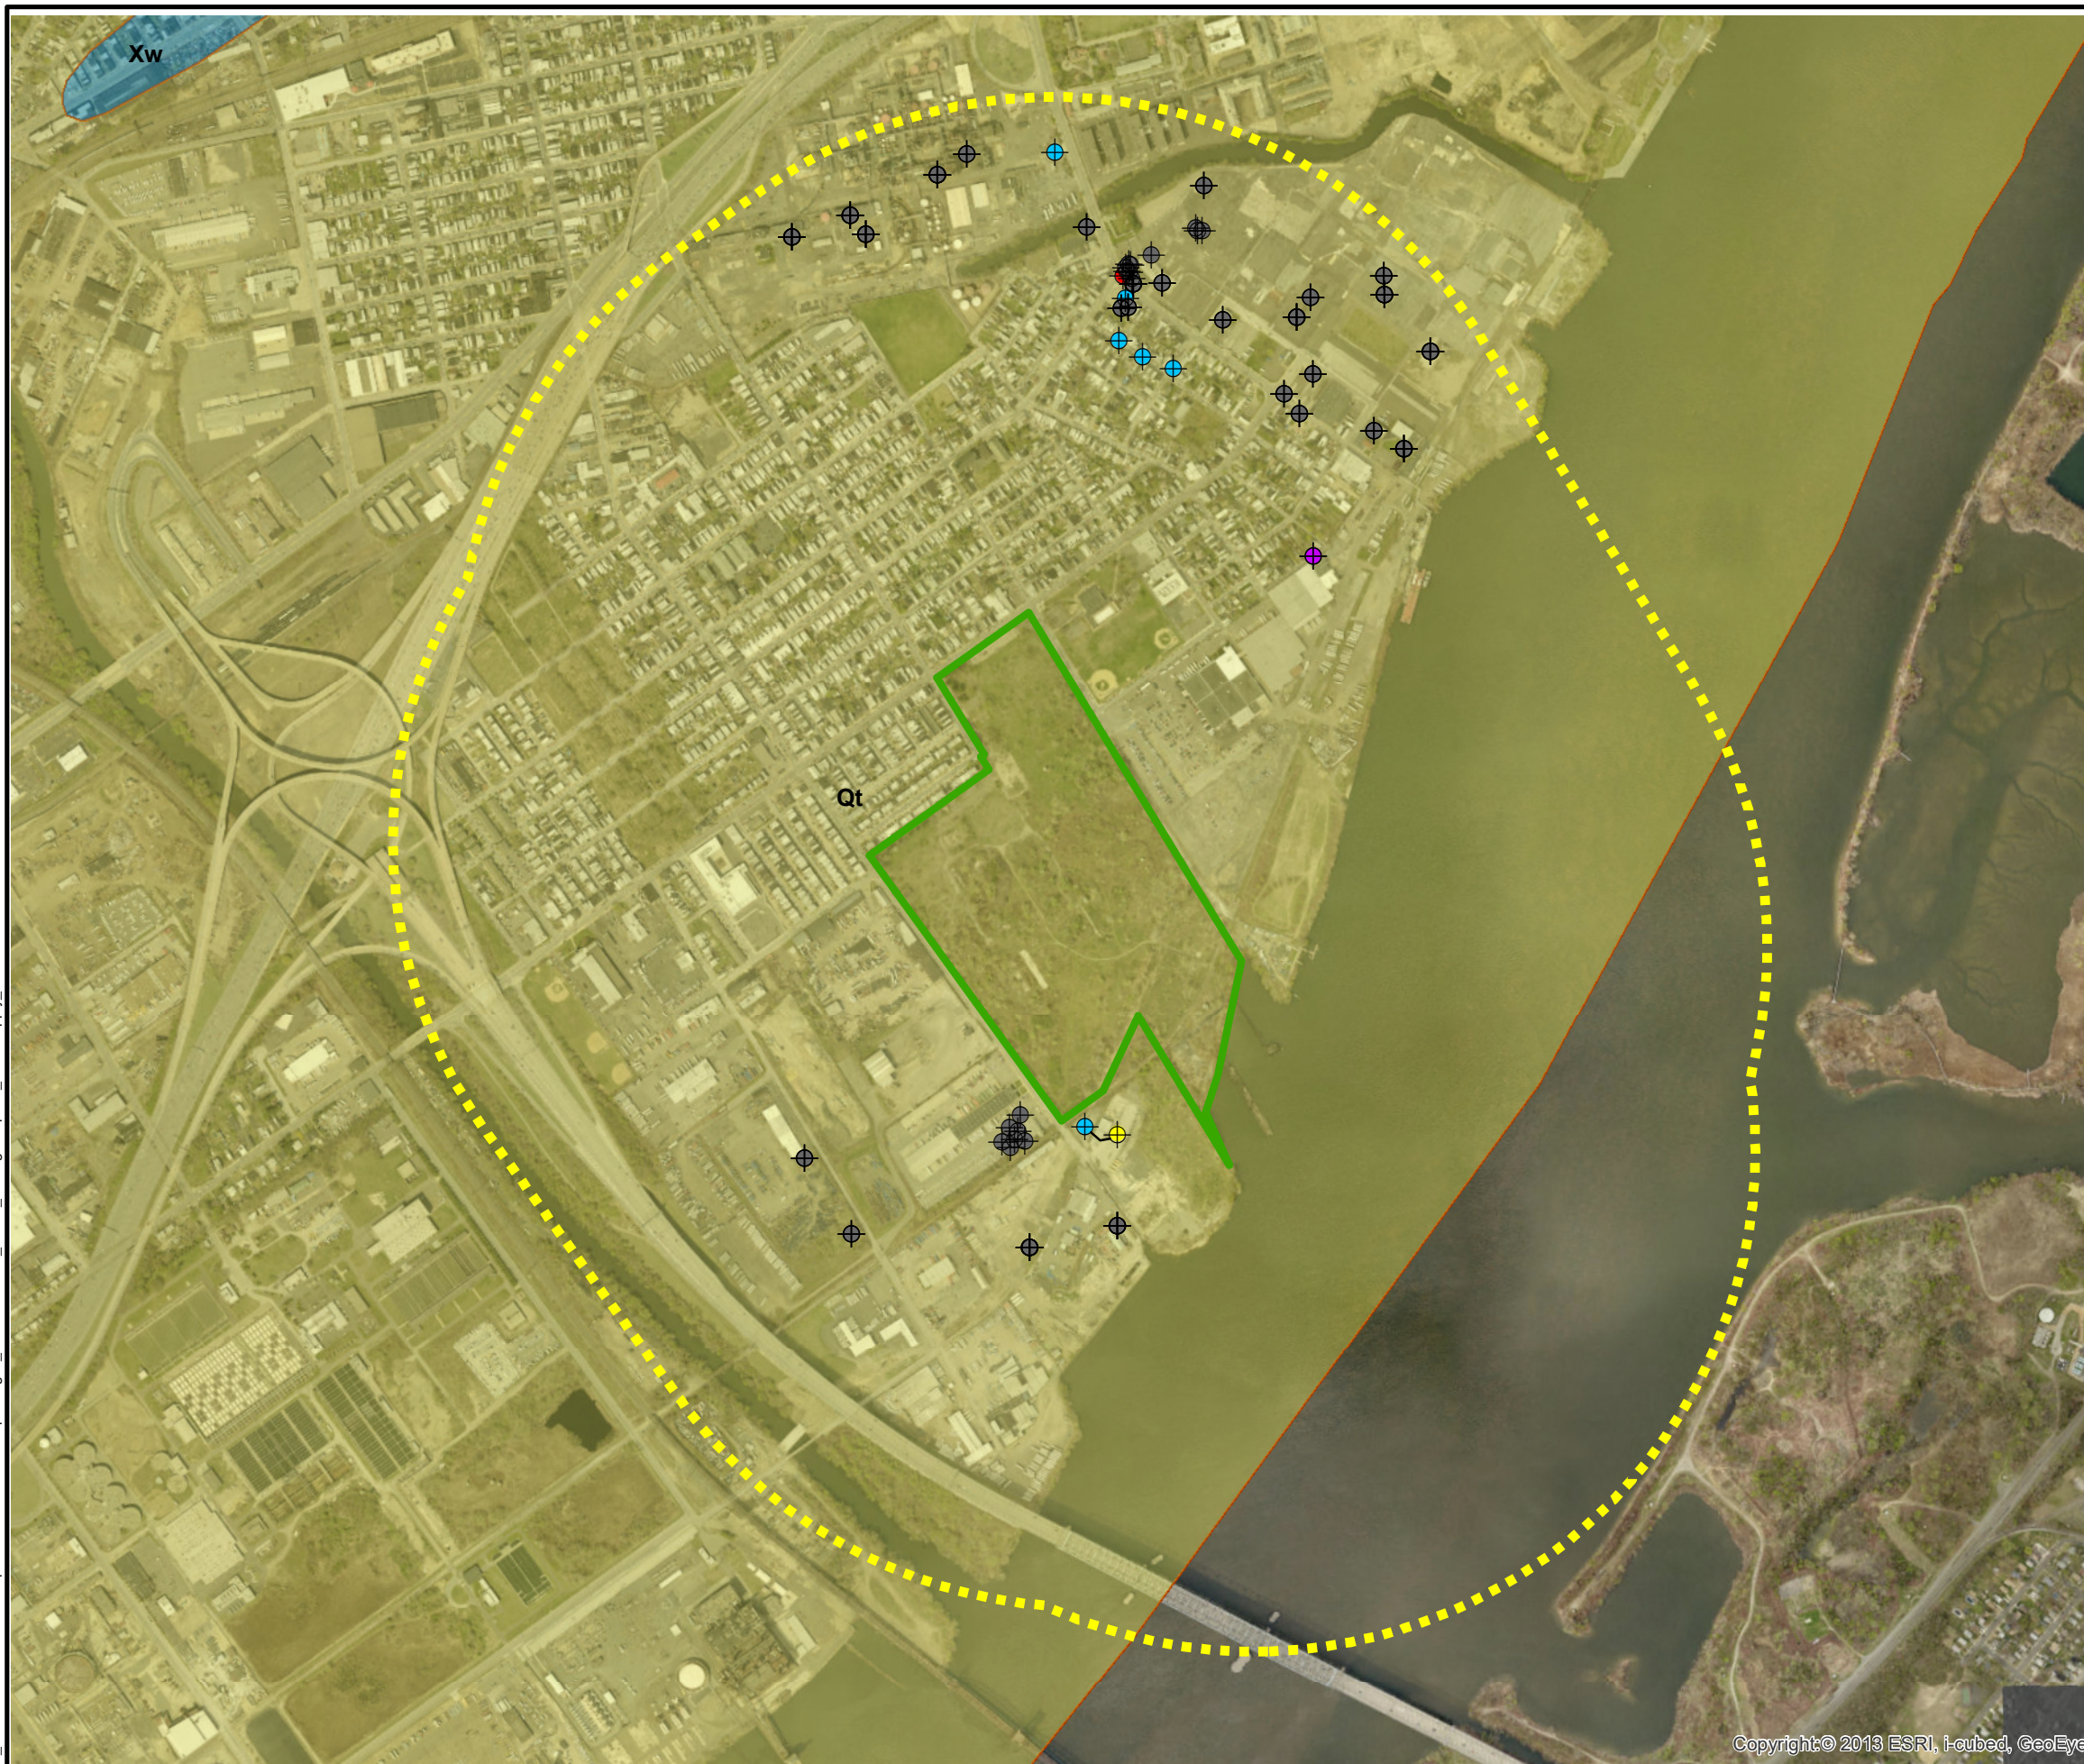
ARCADIS | **FIGURE 12**

**GROUNDWATER POTENTIOMETRIC
 SURFACE MAP - DEEP ZONE
 OCTOBER 3, 2019**

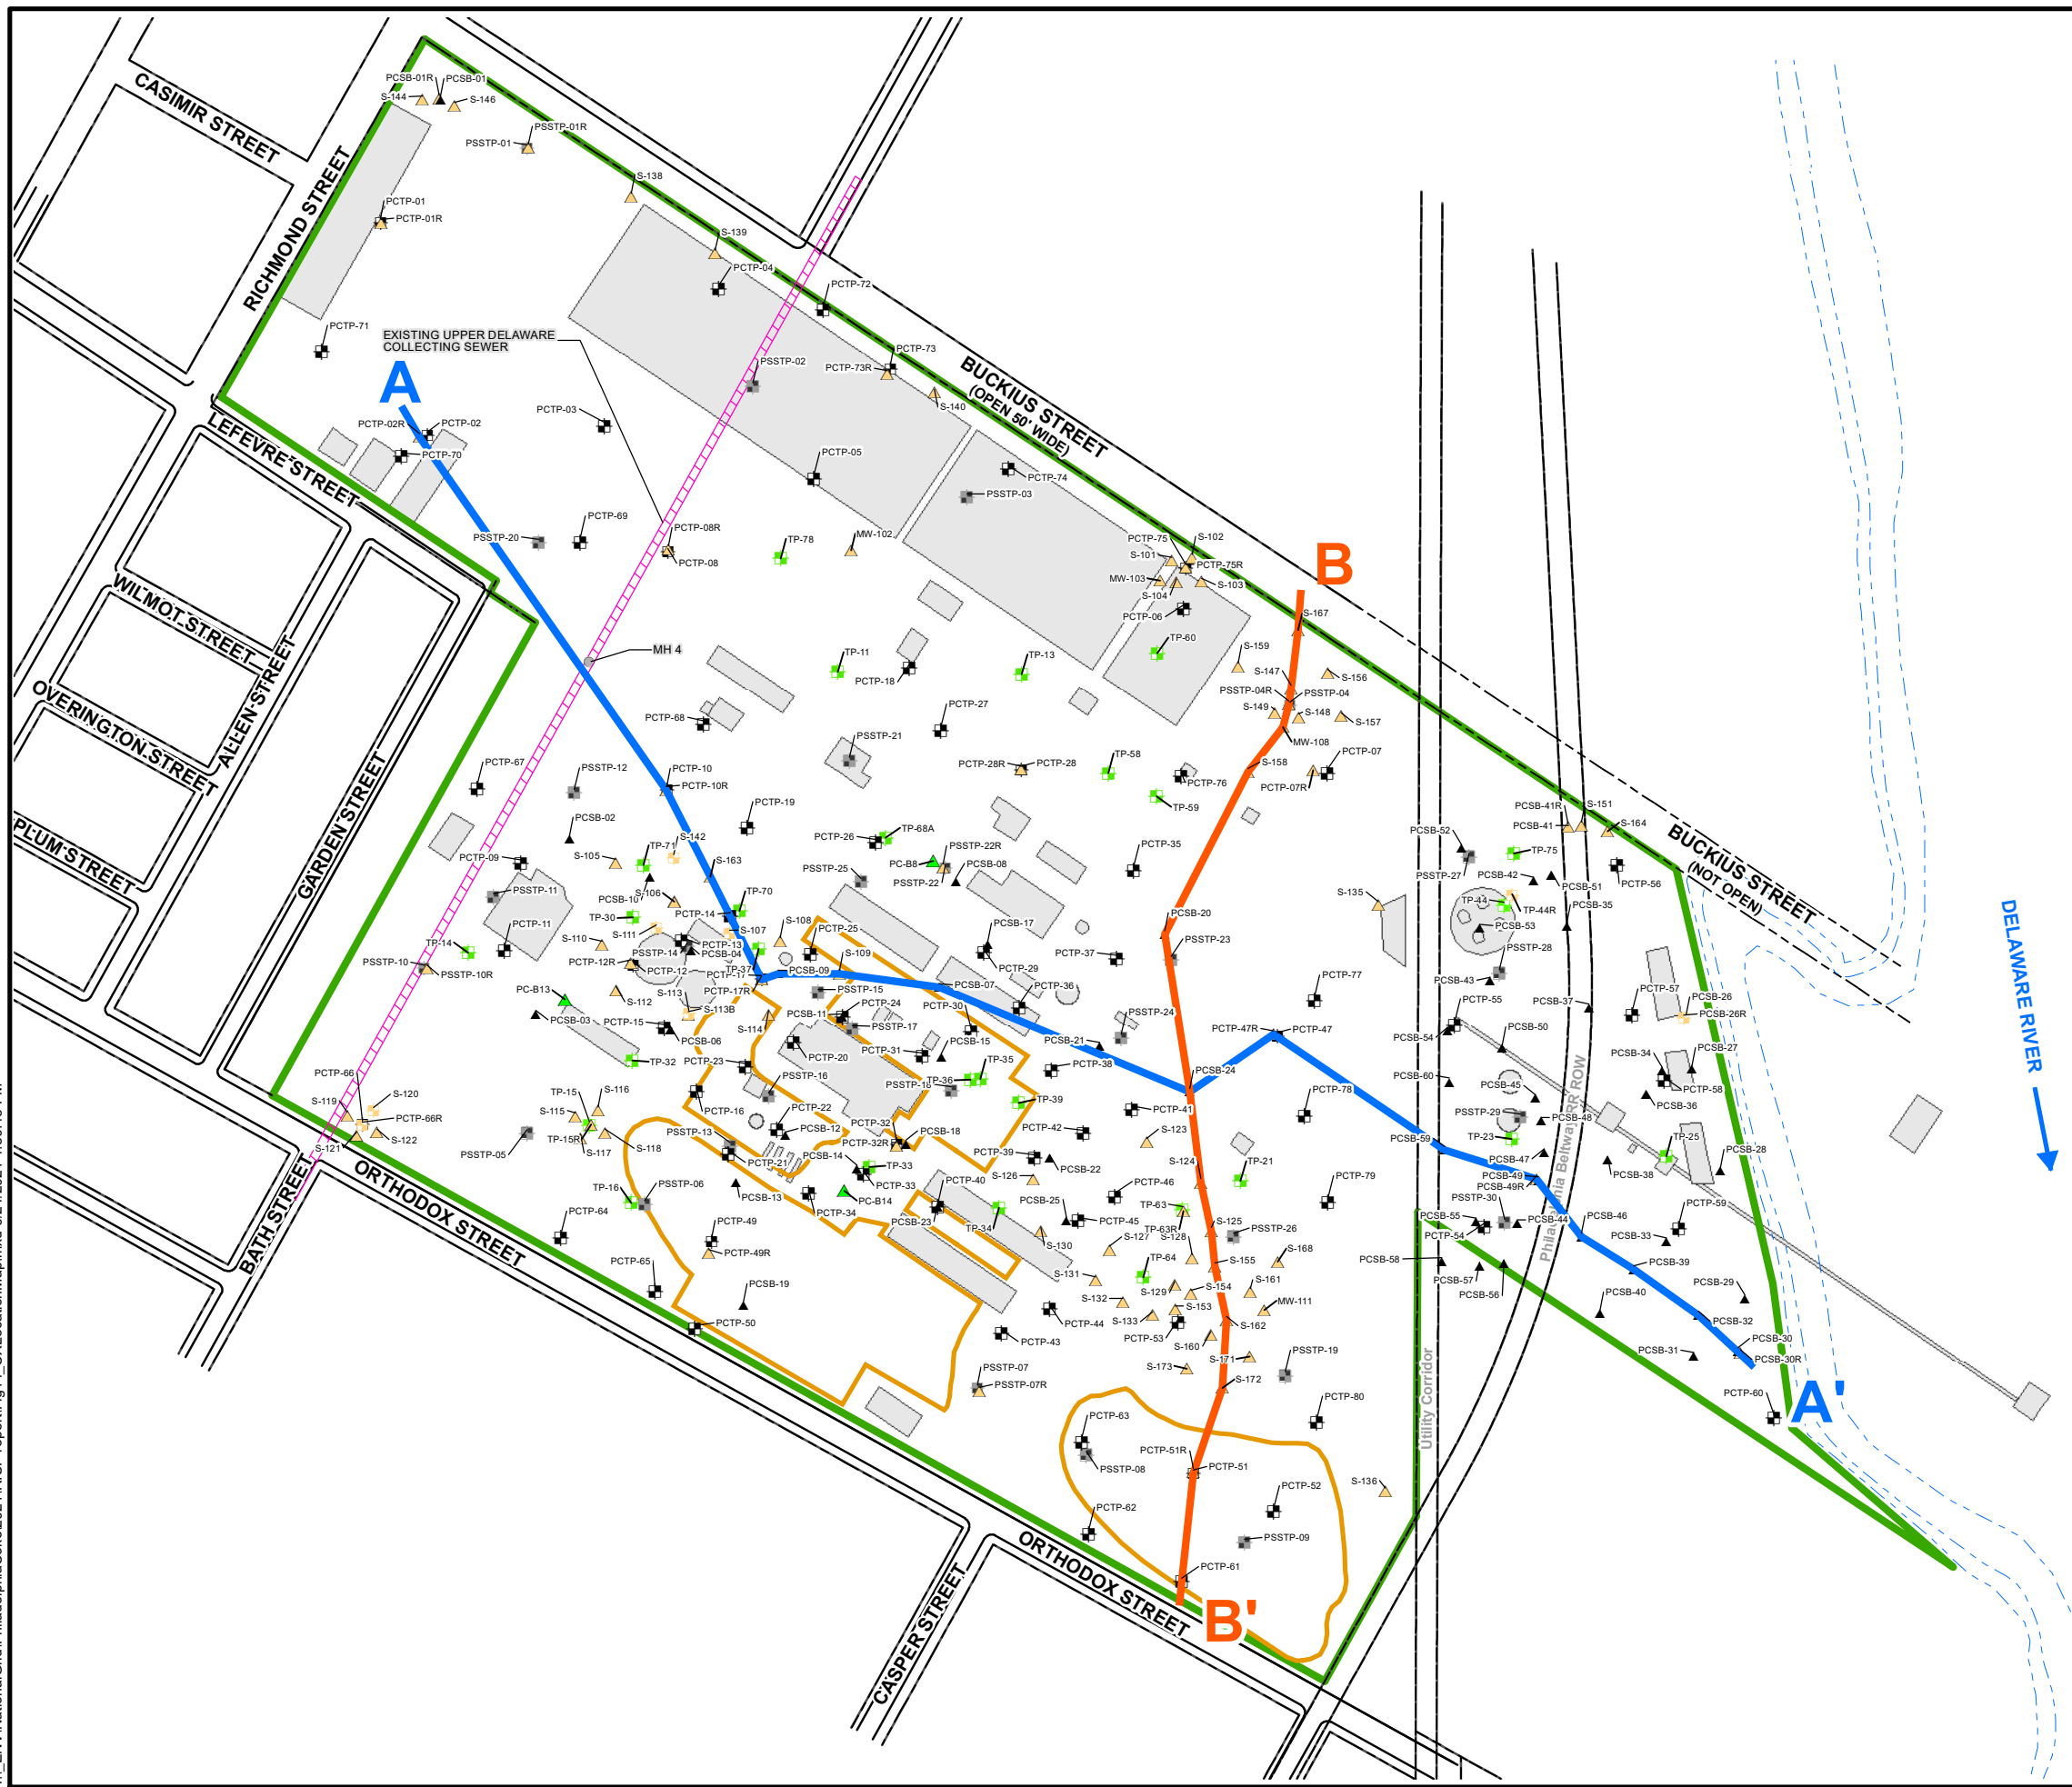
ARCADIS | **FIGURE 13**

**SITE GEOLOGY MAP WITH LOCAL WELLS
 WITHIN HALF MILE RADIUS**

construction that identification is not practical. Native soils are typically displaced by fill material during construction activities. Subsurface investigations confirm the presence of substantial fill materials above native soils at the Site. Fill materials consist of cinders, metal, glass, brick, concrete rubble, coal, ash, and cinders comingled with varying amounts of sand and gravel. The fill material at the Site generally meets the definition of historic fill described in Pennsylvania Department of Environmental Protection's Management of Fill Policy (Document #258-2182-773) dated January 1, 2020. The fill material at the Site ranges in thickness from approximately 10- to 20-feet and is thickest in the northeast portion of the Site. In general, the fill thickness decreases from north to southeast, where it pinches out near the Delaware River. The regional geography near the Site is shown on Figure 13.

Drinking water in Philadelphia is solely sourced from the Delaware and Schuylkill Rivers. Groundwater is not used for drinking water in Philadelphia. As shown in Figure 13 and presented in Appendix I, there are no active groundwater wells at the Site or in the immediate Site area. Therefore, the current exposure pathway for groundwater as potable water or industrial water is incomplete. In the future, as part of the Site redevelopment, institutional controls will be established that prohibit groundwater use.
