February 6, 2023 Contractor HASP Submittal to EPA

From: Brussel, John
Sent: Monday, February 6, 2023 9:23 PM
To: Bilash, Kevin
Cc: Stearns, Brian M.; Sheehan, Daniel P.; Healy, Lawrence
Subject: Contractor's Construction HASP - Former Philadelphia Coke Site, 4501 Richmond Street, Philadelphia, PA

**PROJECT HEALTH & SAFETY PLAN (HASP)
BRIDGE POINT BRIDESBURG LLC
4501 RICHMOND STREET
PHILADELPHIA, PA**

Envirosearch Project # 43322

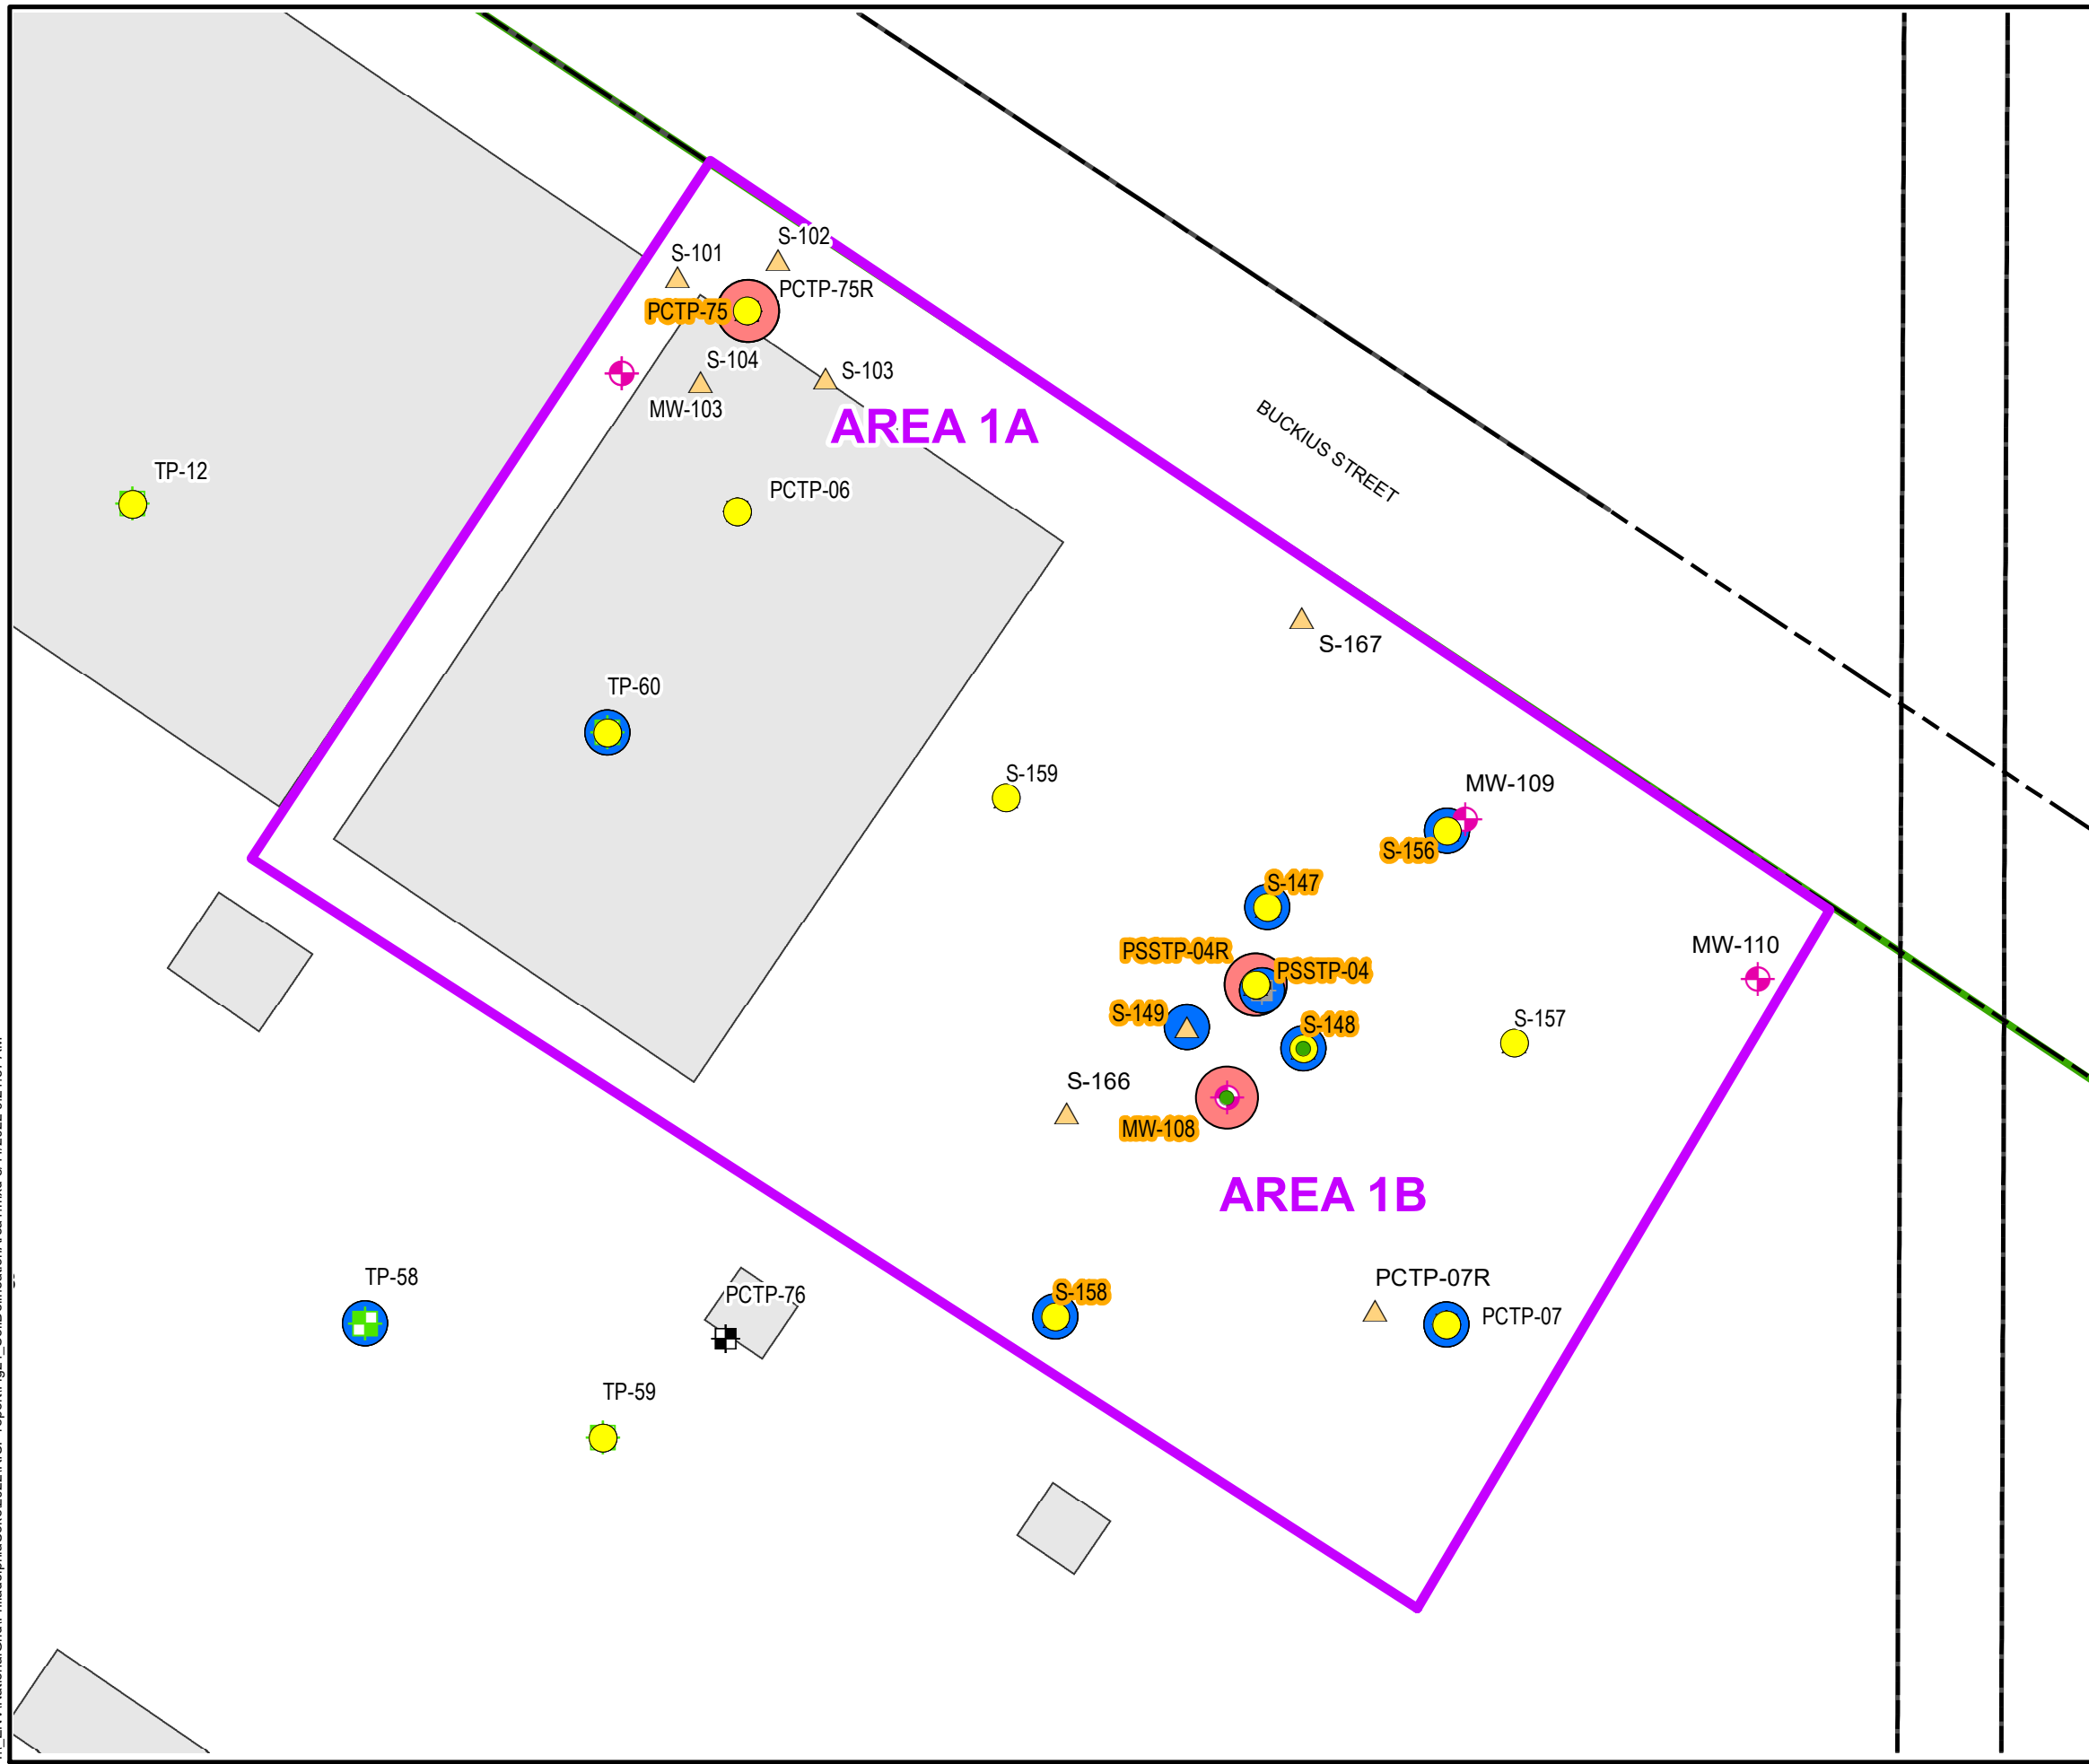
SOIL DELINEATION AREAS

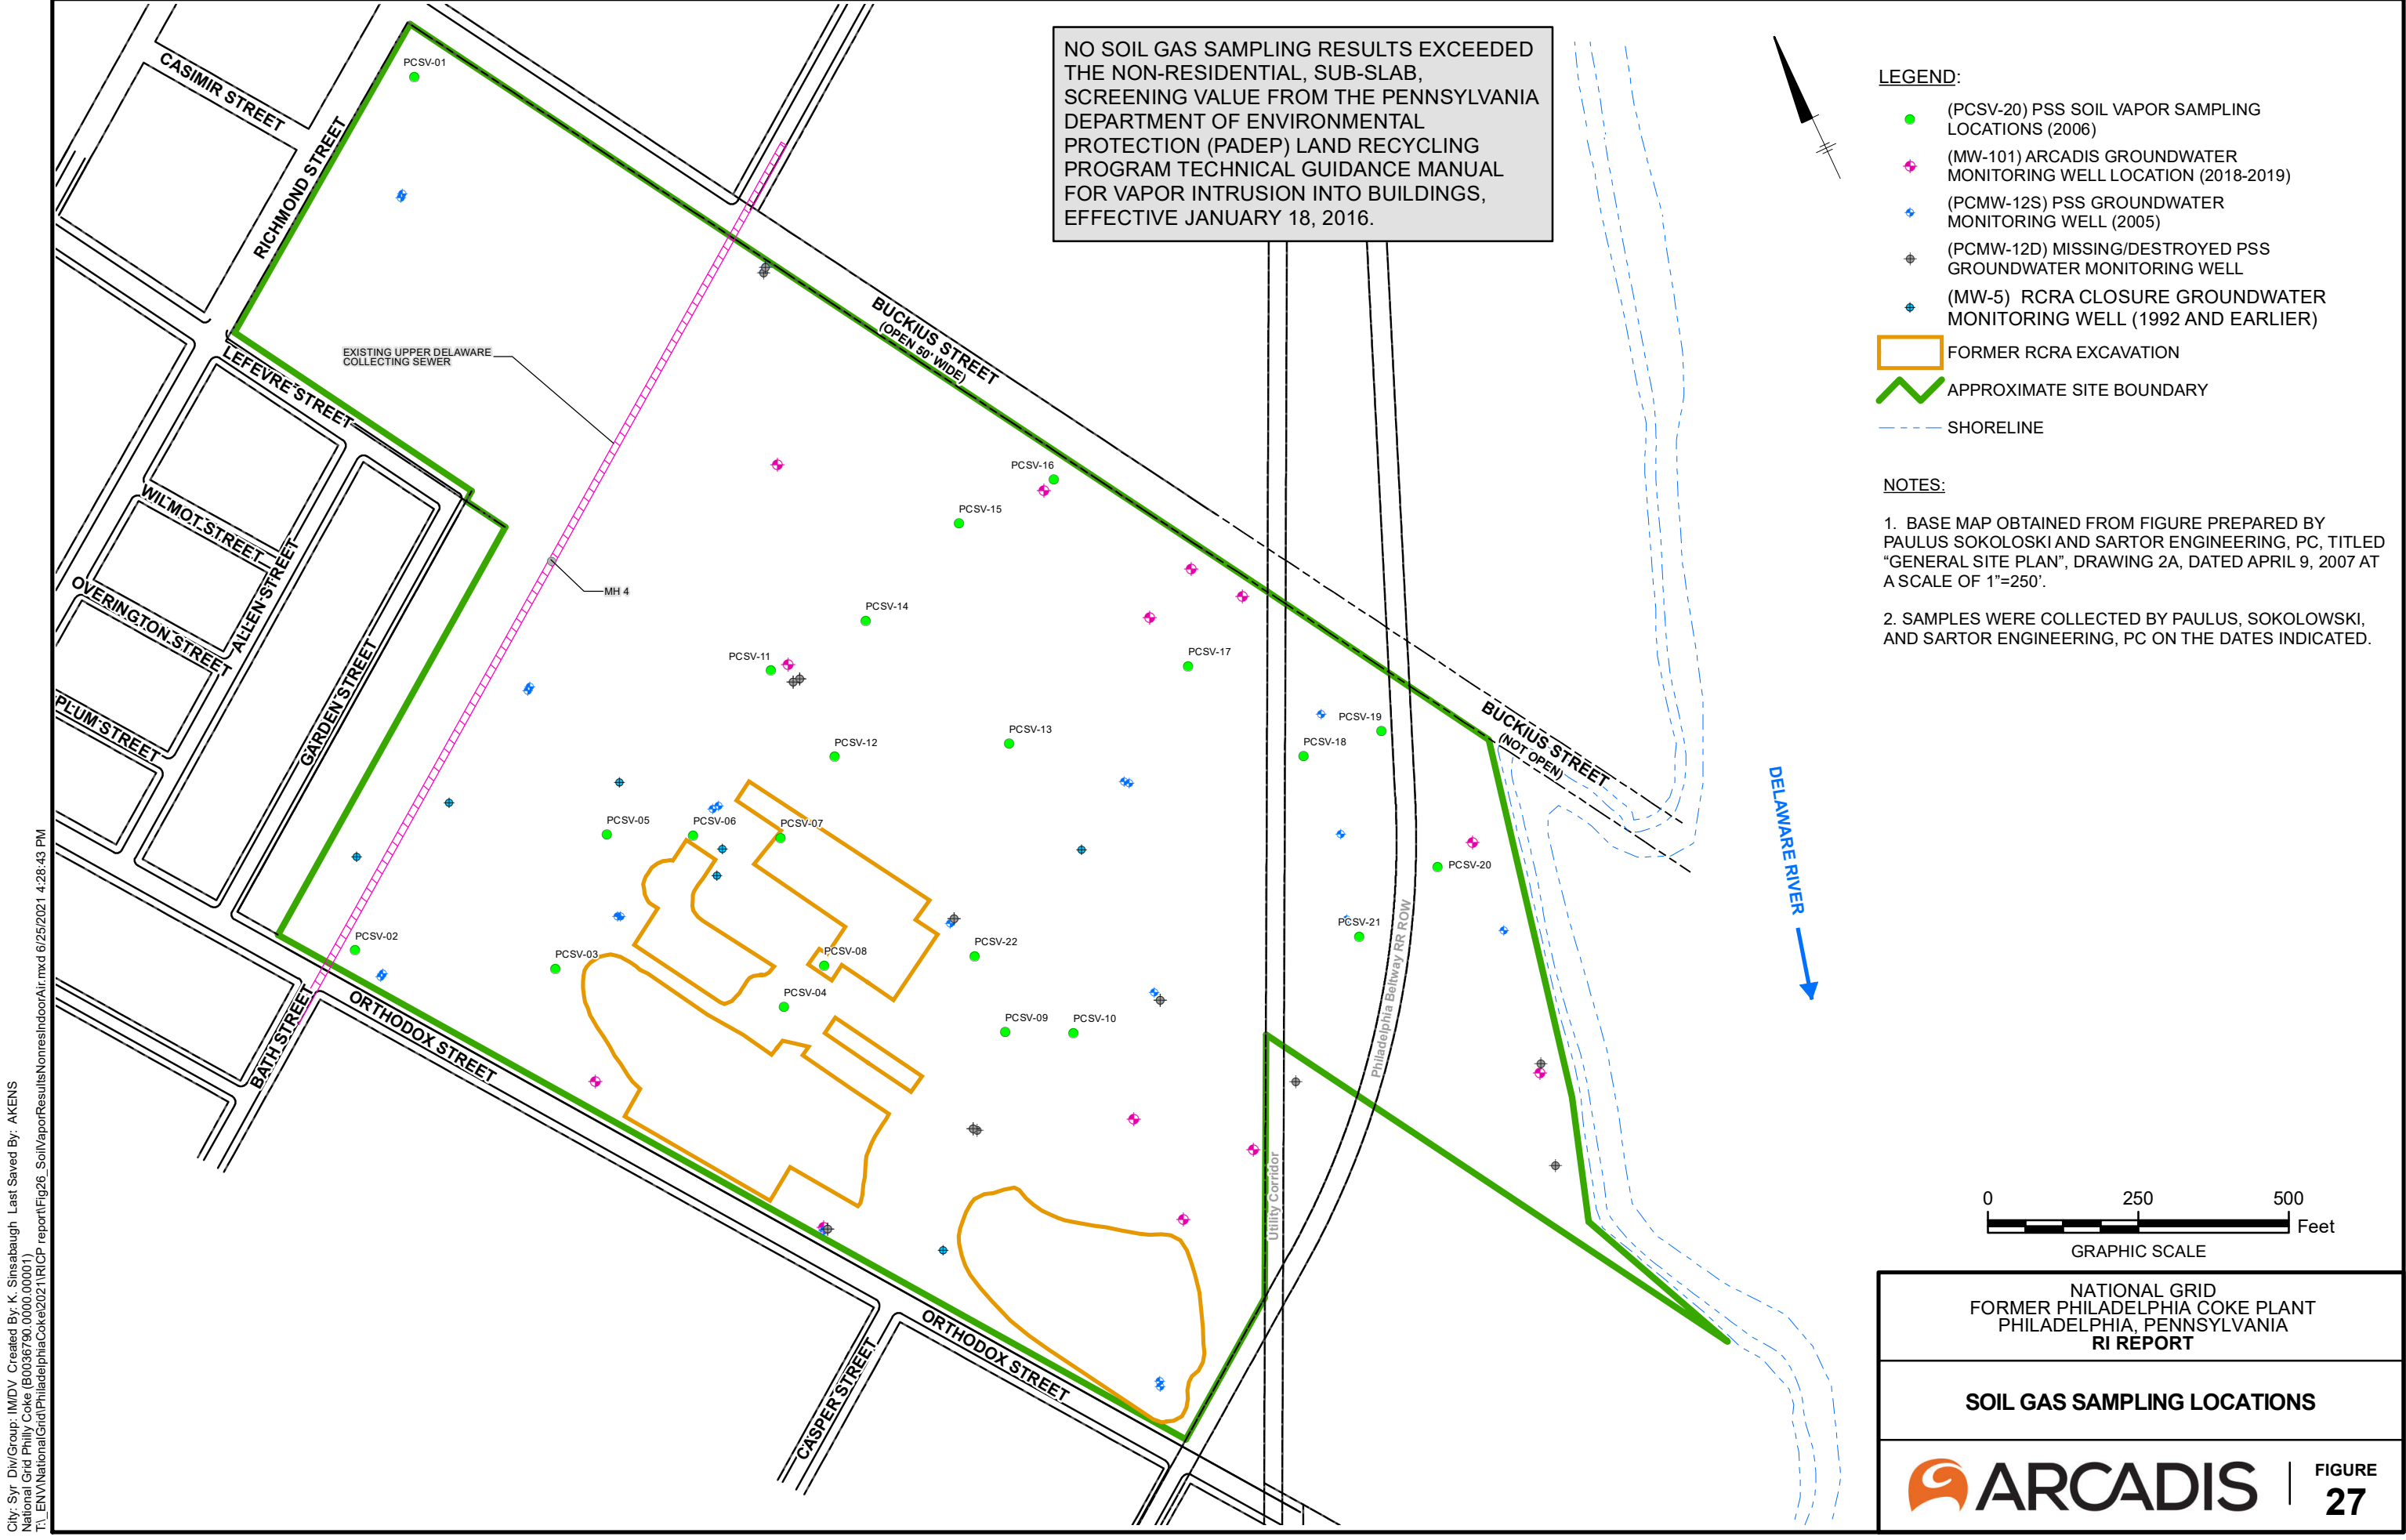
NATIONAL GRID FORMER PHILADELPHIA COKE PLANT PHILADELPHIA, PENNSYLVANIA RI REPORT	
SOIL GAS SAMPLING LOCATIONS	
	FIGURE 27

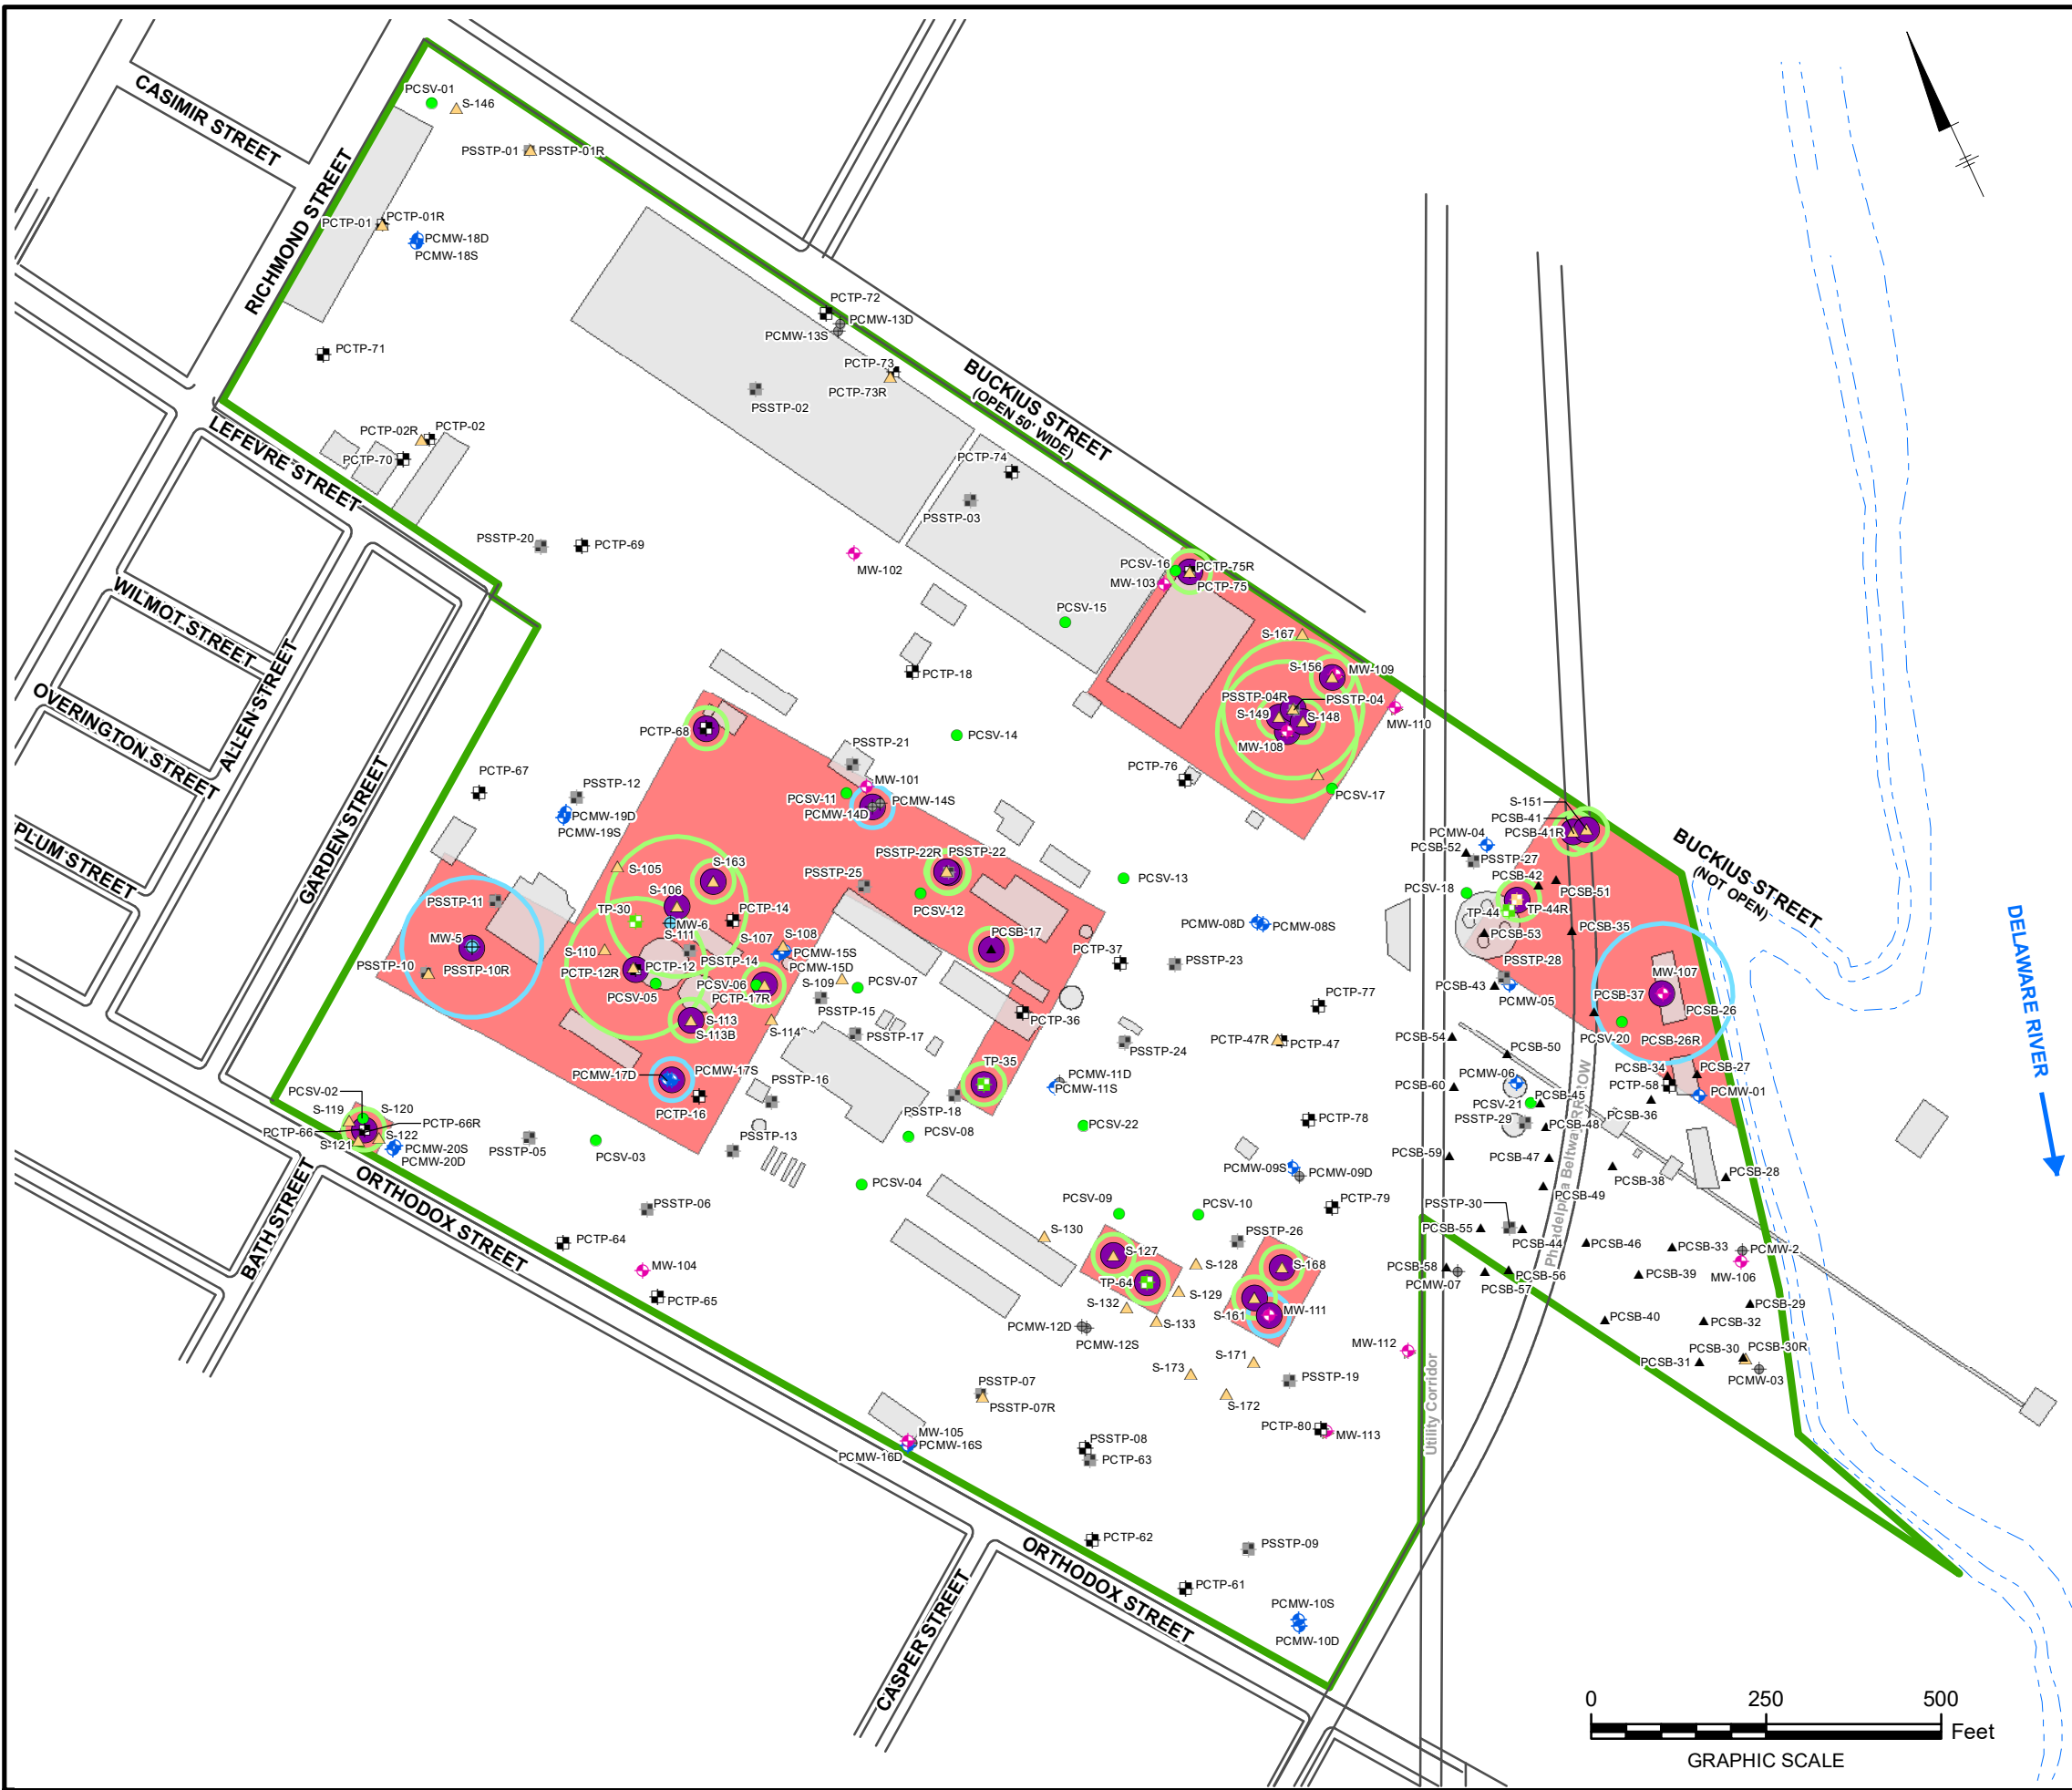
FIGURE
' 5 '

- APPROXIMATE AREAS WHERE POTENTIAL BUILDINGS WILL NEED VAPOR INTRUSION MITIGATION MEASURES OR ADDITIONAL VAPOR INTRUSION EVALUATION IS NEEDED
- PROXIMITY DISTANCE AROUND POTENTIAL VAPOR INTRUSION CONCERN FROM SOIL

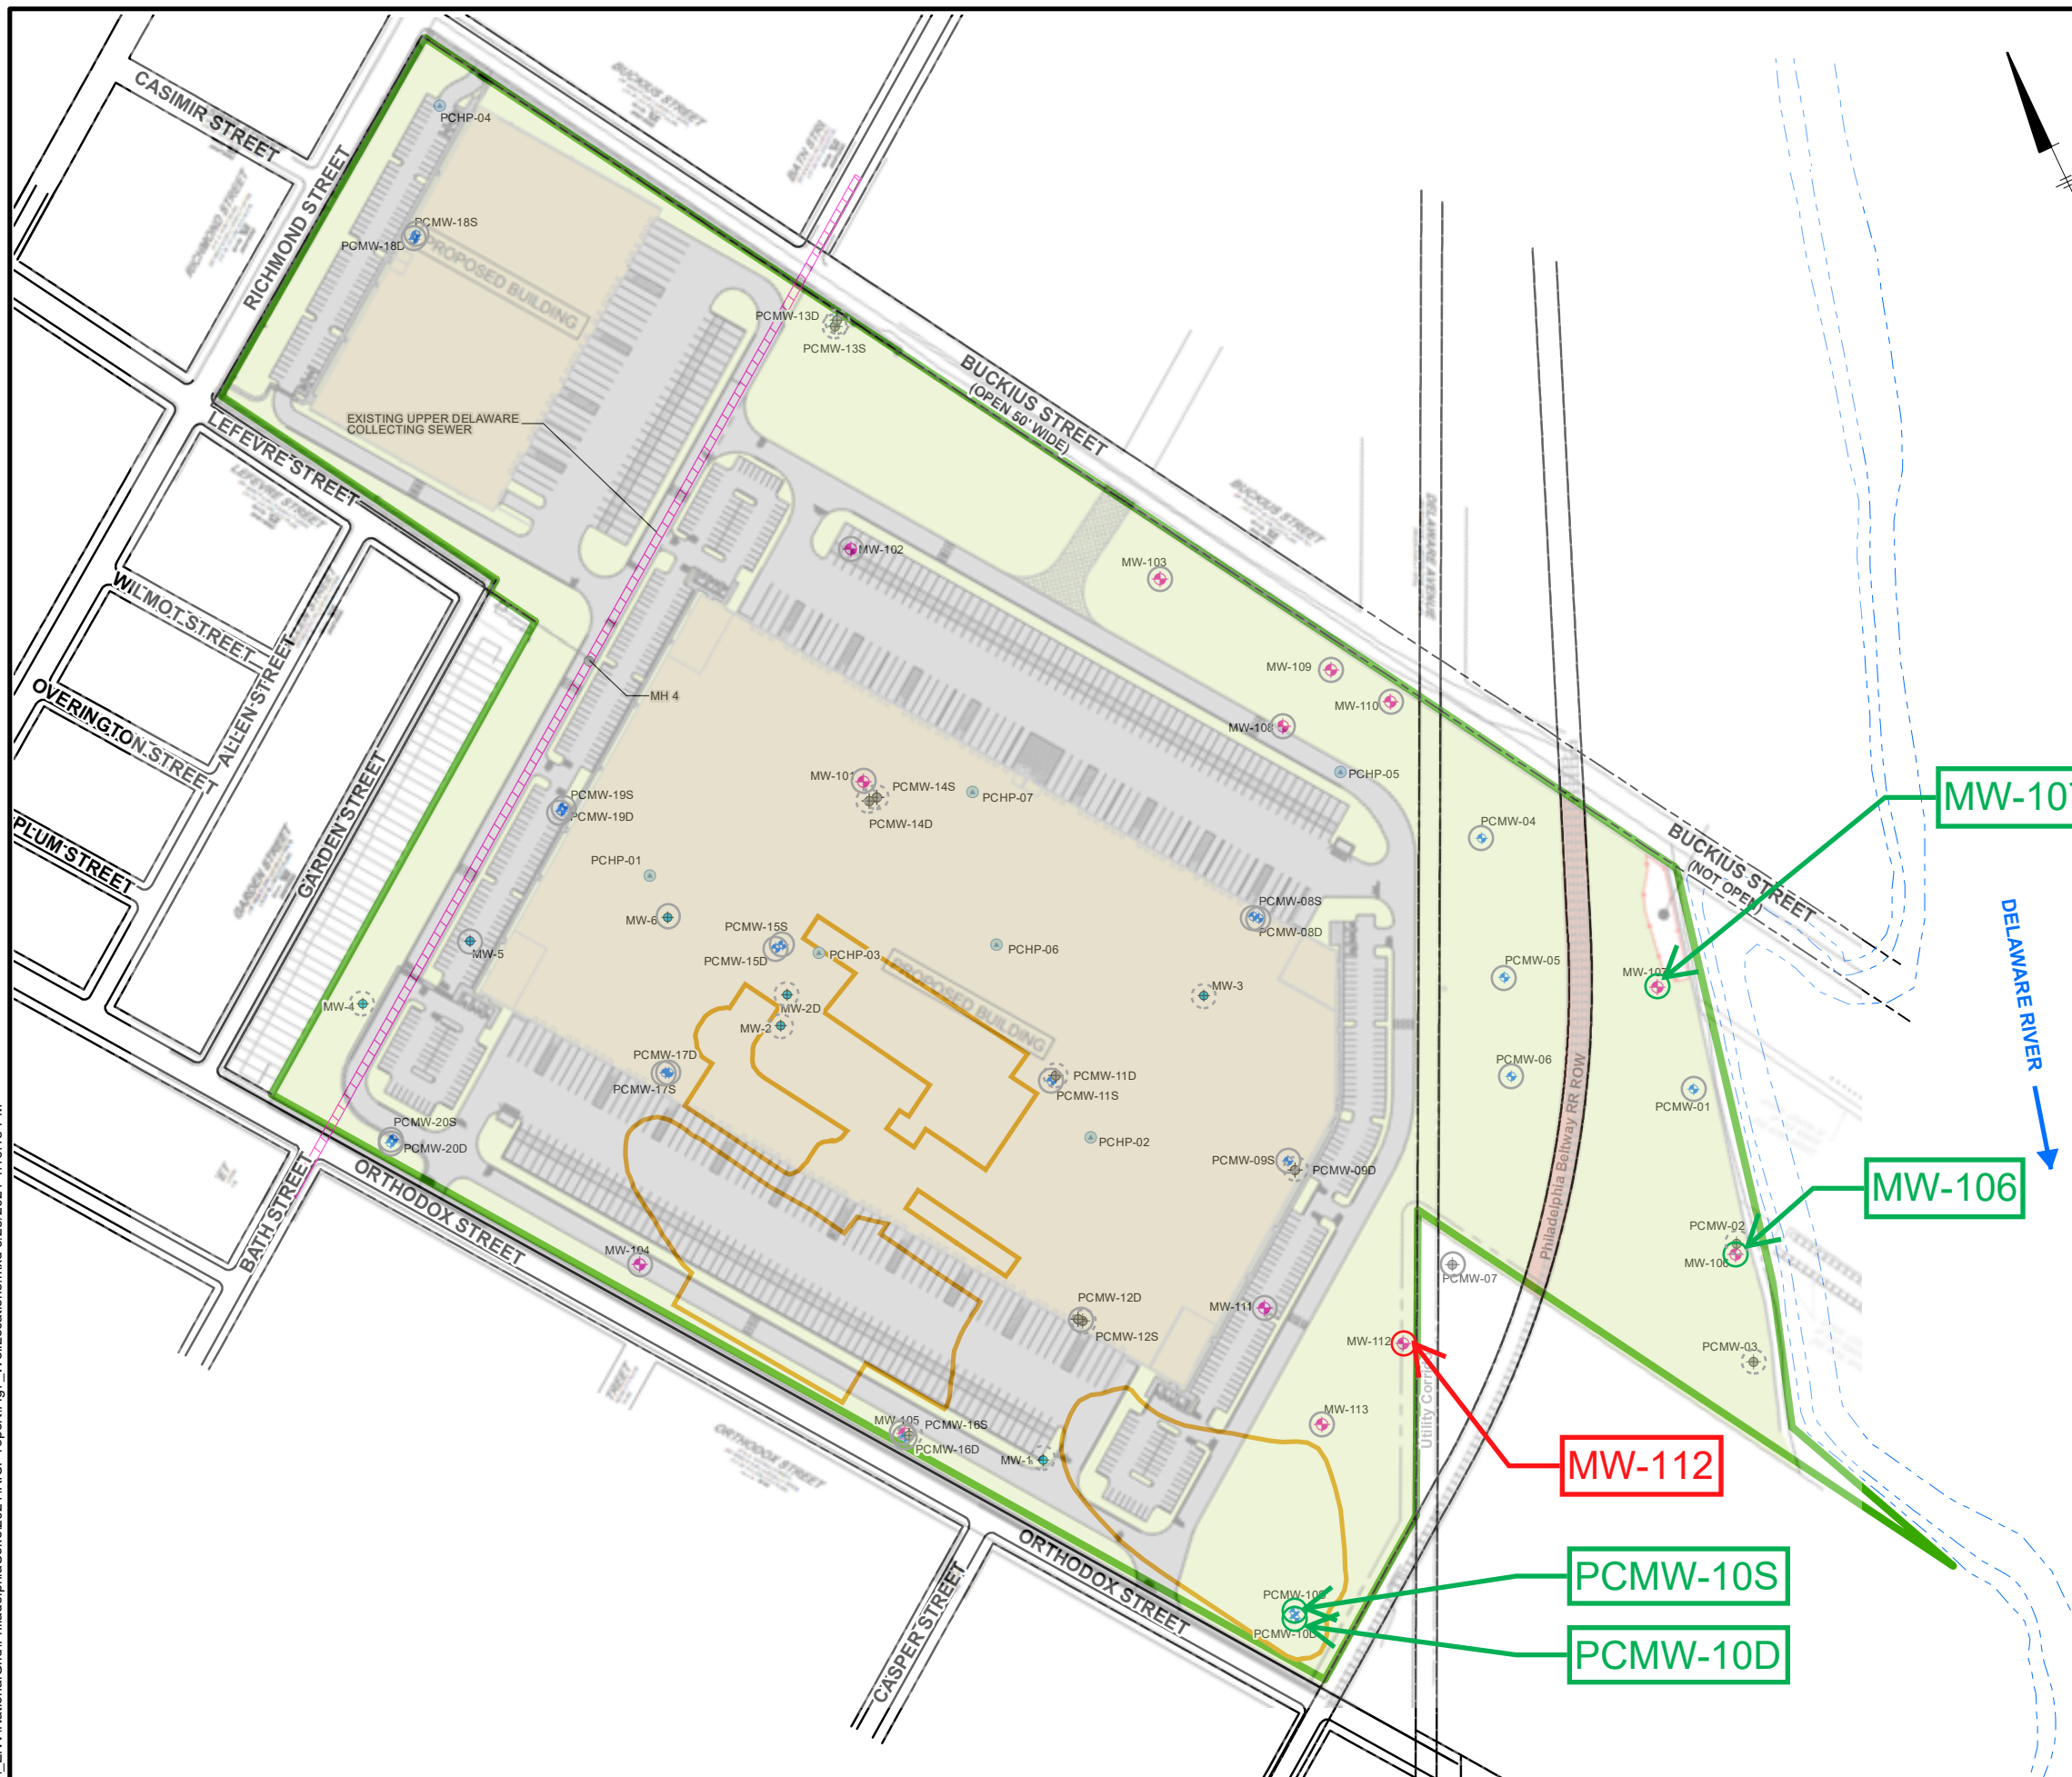
- LEGEND:**
- MONITORING WELL PROPOSED FOR DECOMMISSIONING
 - MONITORING WELLS PROPOSED FOR PROTECTION AND MAINTENANCE DURING SITE REDEVELOPMENT
 - DECOMMISSIONED MONITORING WELL
 - MONITORING WELLS THAT WERE NOT LOCATED, DESPITE BEST EFFORTS TO LOCATE
 - ◆ (MW-101) ARCADIS GROUNDWATER MONITORING WELL LOCATION (2018-2019)
 - ◆ (PCMW-12S) PSS GROUNDWATER MONITORING WELL (2005)
 - ◆ (PCMW-12D) MISSING/DESTROYED PSS GROUNDWATER MONITORING WELL
 - (PCHP-03) PSS GROUNDWATER HYDROPUNCH (2005)
 - ◆ (MW-5) RCRA CLOSURE GROUNDWATER MONITORING WELL (1992 AND EARLIER)
 - FORMER RCRA EXCAVATION
 - APPROXIMATE SITE BOUNDARY
 - SHORELINE
